## 2015 Operations, Maintenance, and Monitoring Report

## Black Bayou Hydrologic Restoration

State Project Number CS-27  
Priority Project List 6

June 2015  
Calcasieu and Cameron Parishes

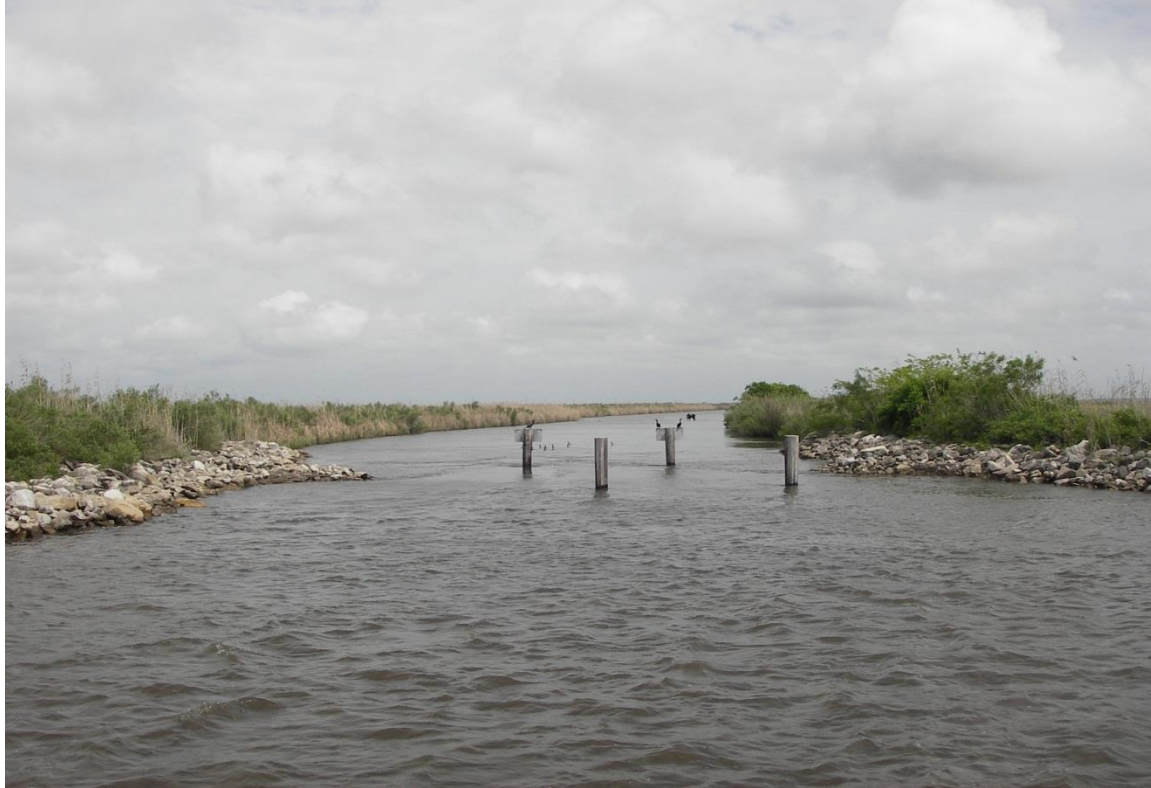
The rock weir seems to be in excellent condition, however landowners indicated that there was some scouring on the inlet and outlet sides of the weir. Upon further investigation, it was found that water was approximately 20 feet deep on the Black Bayou side and approximately 14 feet deep on the inside of the structure. Water depth at the sill is approximately 4.5 feet deep. The two arrow signs on the Black Bayou side of the structure are still missing and will need to be replaced. The erosion on the SE will continue to be monitored, but has stabilized. Navigational lights and signs are inspected quarterly by contractor. (Photos: Appendix A, Photo 1)

**Photo 1**—Navigational Aids and signage at Block's Creek

Item	Condition	Physical Damage	Corrosion	Photo #	Observations and Remarks
Block's Creek Weir	Good			1	Scouring taking place on each side of the structure. 20 ft deep on Black Bayou side and 14ft deep on interior. Sill is at 4.5ft. Two arrow signs are missing. No other maintenance required at this time.
Burton Canal Weir	Good			2	Scouring taking place on each side of the of the wier. 29.5ft on Sabine river side and 33.7ft deep on interior. Sill is at 6.5ft
Black Bayou Cut-Off Canal Weir	Good			3	Scouring is taking place on each side of the weir. 33.5ft deep on the GIWW side and 23ft deep on interior. Sill is at 10.5ft deep.
Culvert1/Culvert2	good			13-16	Good condition
Timber Piles	N/A				
Timber Wales	N/A				
Galv. Pile Caps	N/A				
Navigational Aid Lights	Good				Inspected quarterly.
Signage /Supports	Good				See note on Block's creek
Rip Rap	Good

1. Replace stolen warning signs at both the Vinton and Black Bayou closures.
2. Task an engineering firm to evaluate the extent of scouring around the three weir structures and estimate a repair cost.

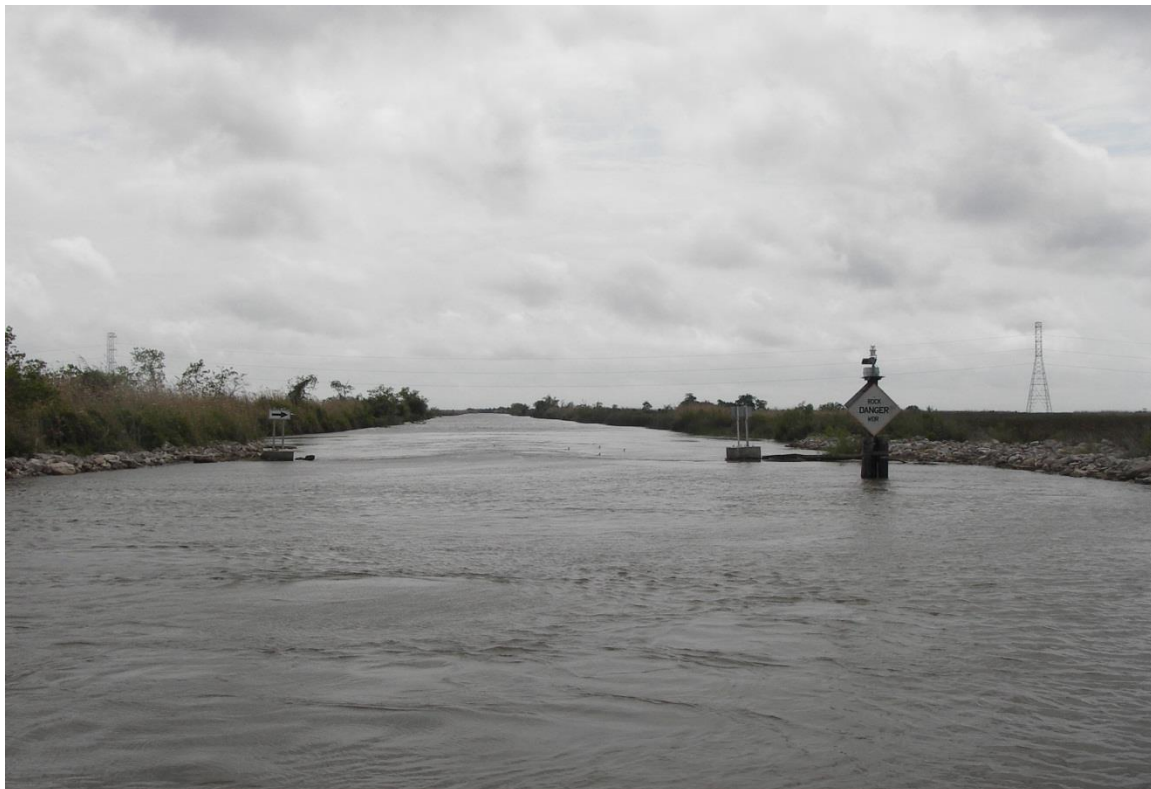
The situation at this weir is the same as at Block's Creek. Water levels on the Sabine River side are approximately 29.5 feet deep and on the inside of the structure, 33.7 feet deep. The sill is at 6.5 feet deep. The scouring along the canal banks inside of the weir at the end of the dike has stabilized. The arrow sign on the SW side of the structure is missing and will need to be replaced. Navigational lights and signs are inspected quarterly by contractor. (Photos: Appendix A, Photo 2)

**Photo 2**—Burton Canal Structure w/ missing SW arrow sign

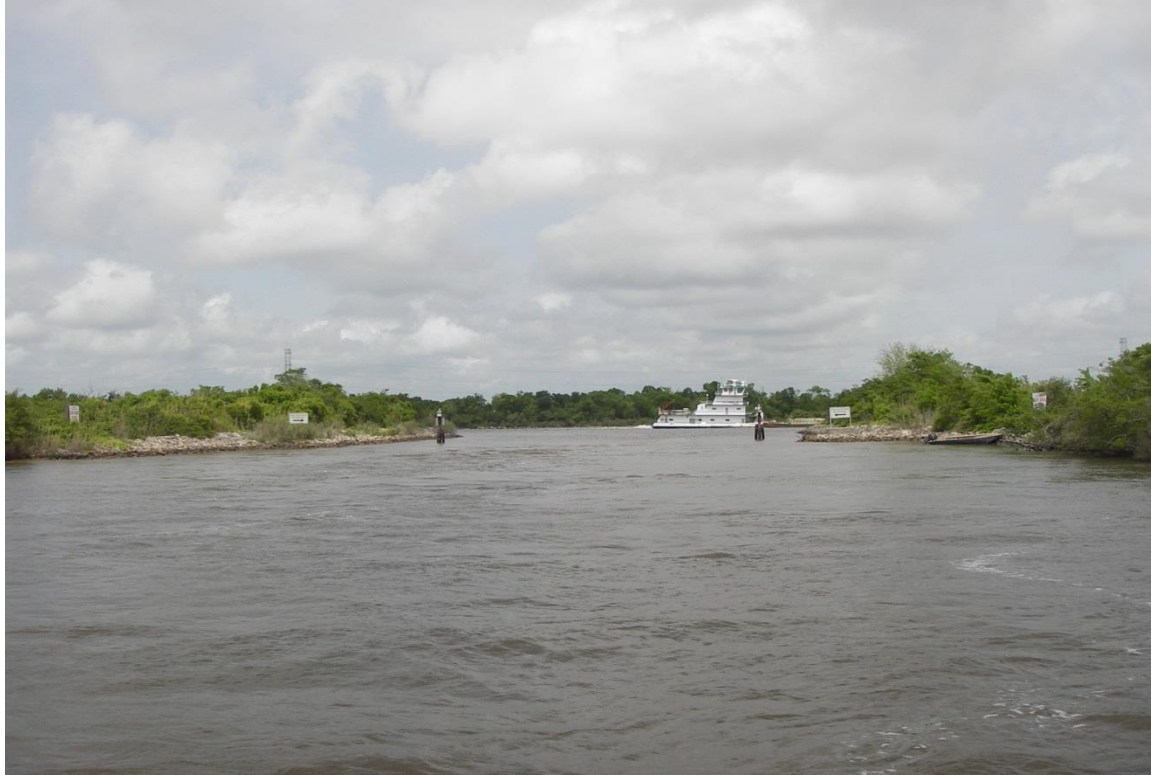
Scouring around the structure has occurred here as well. Water depths were 33.5 feet deep on the GIWW side and 23 feet deep on the inside. Sill depth is 10.5 feet. Navigational lights and signs are inspected quarterly by contractor. Coast Guard signs on the inside of the structure were missing at the time of this inspection. (Photos: Appendix A, Photo 3)

**Photo 3—Black Bayou Cut Off Canal structure**

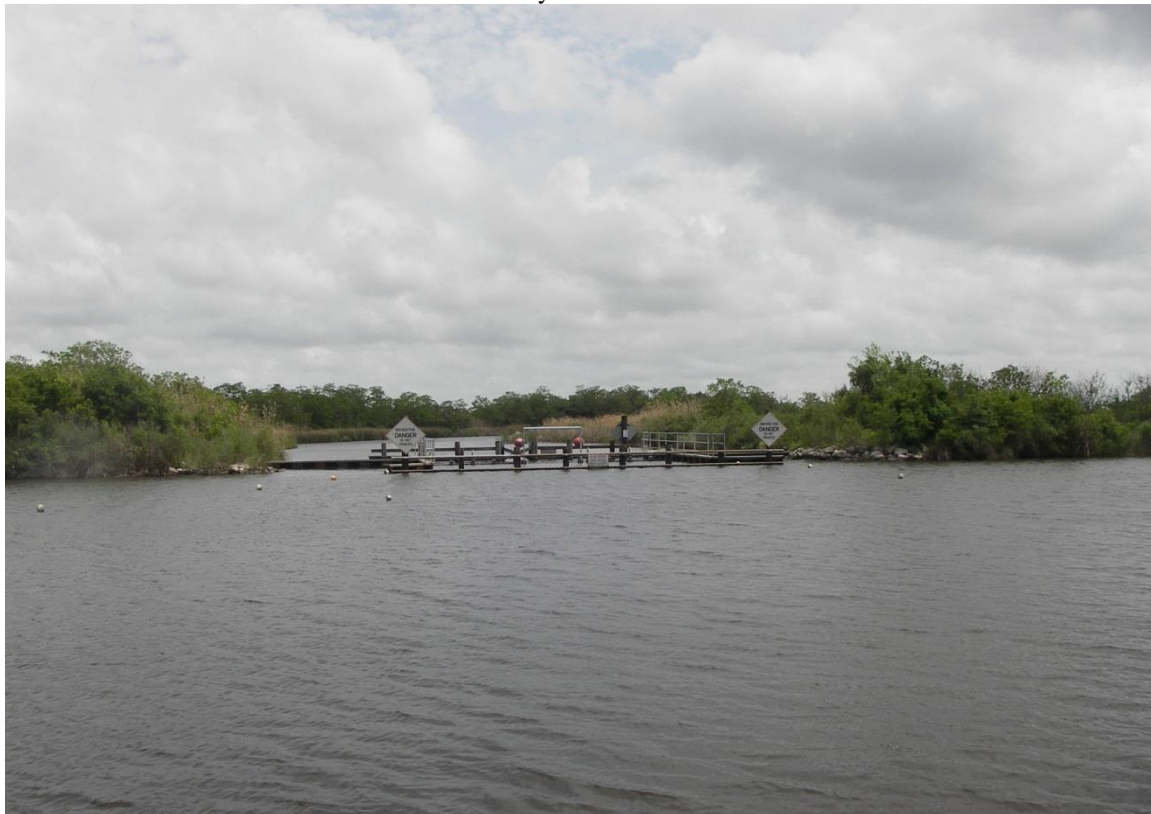
**Photo 4—SRT Gate**

The structure is in very good condition. Pillow blocks, signage, railings, wingwalls, etc. remain in excellent condition. The railing along the top of the gate continues to rust and will have to be monitored. The seams at the sheet piles are rusting also, however there is no need for maintenance at this time. Colonies of oysters were noticed on the rocks on the outside of the structure and none on the inside. (Photos: Appendix A, Photos 4-6)

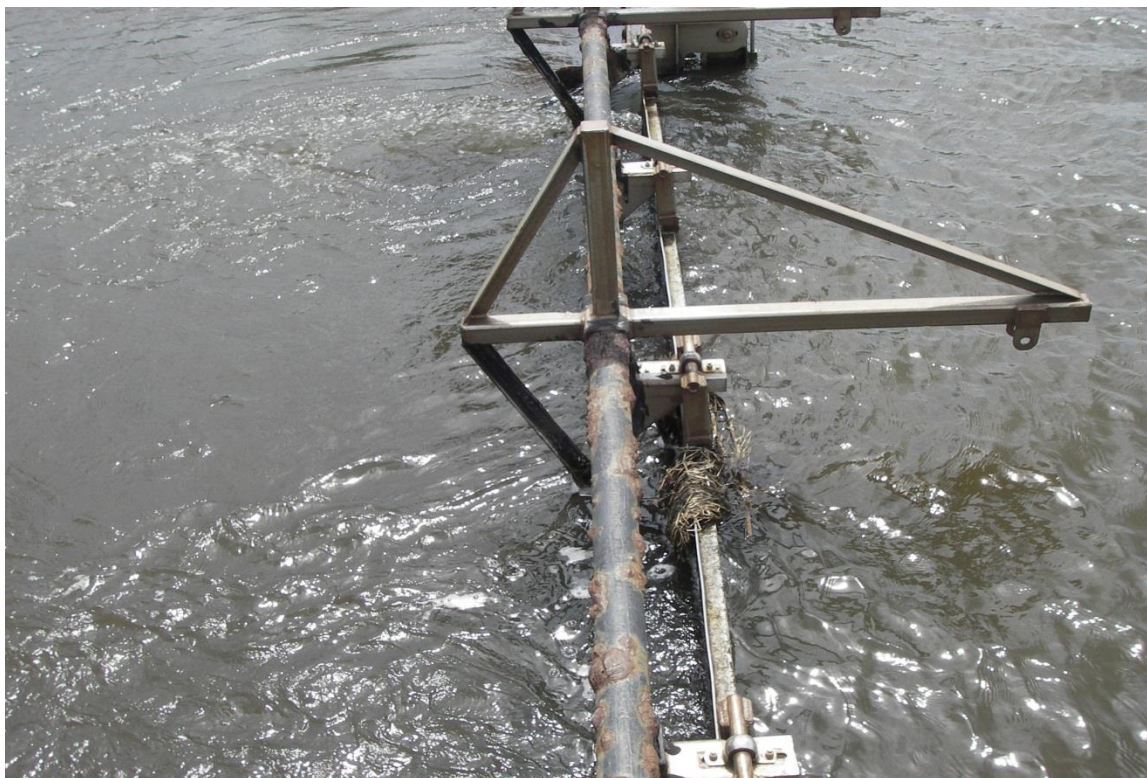
**Photo 5**—pillow block on SRT Gate flap & railing rust

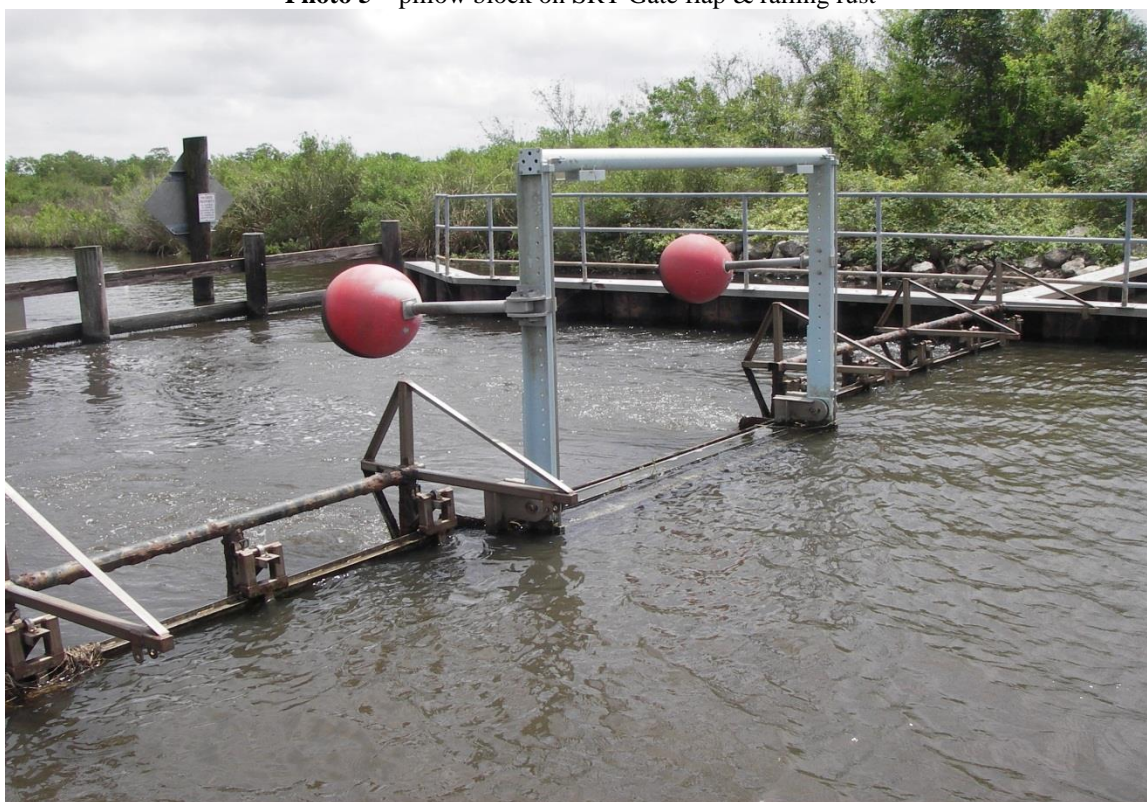
**Photo 6**—SRT Gate

Item	Condition	Physical Damage	Corrosion	Photo #	Observations and Remarks
Steel Bulkhead / Caps	Good			6	Rusting at sheet pile seams. Will continue to monitor.
Steel Grating	N/A				
Stop Logs	N/A				
Hardware	Good				
Timber Piles	Good				
Timber Wales	Good				
Galv. Pile Caps	Good				
SRT Gate	Good		Moderate	4-6	Pillow blocks were replaced during last inspection. Gate is in good condition. The railing above the gate is showing signs of corrosion. No maintenance required at this time.
Signage / Supports Vinton Canal	Good			4	Good condition.
Rip Rap (fill)	Good				
Rock Plug (Concrete sack repair)	Good			7	Good condition

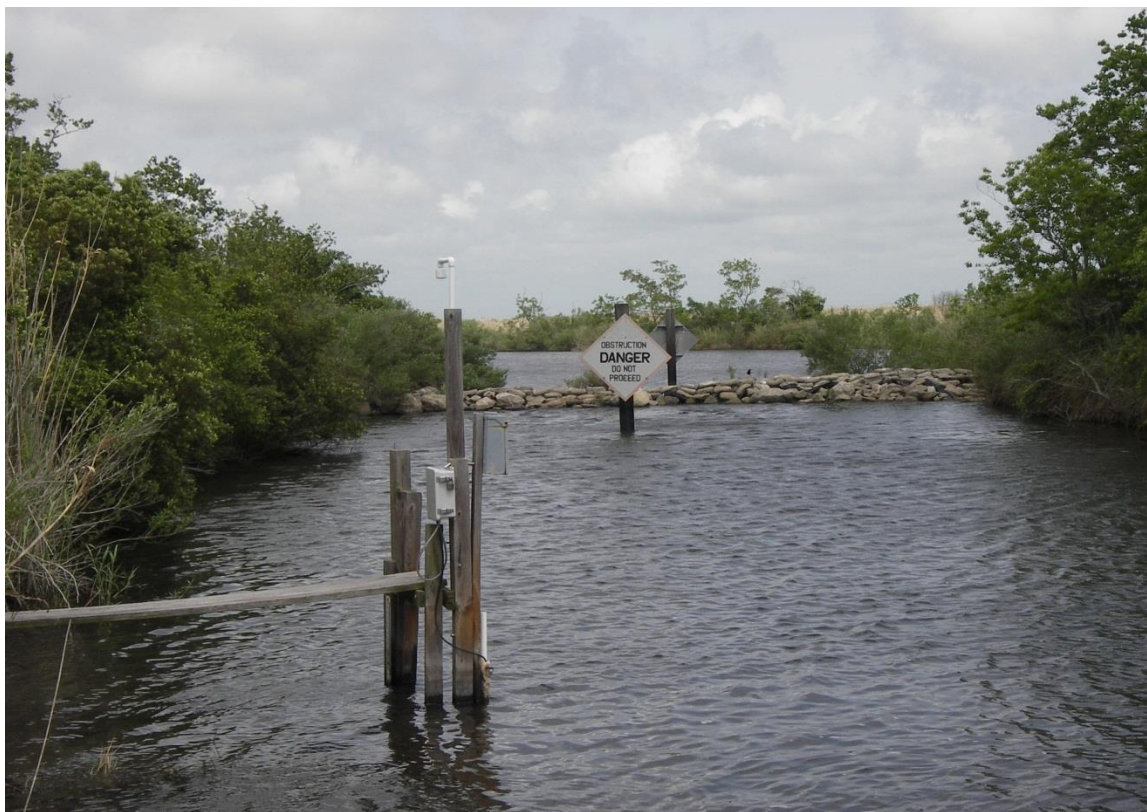
**Photo 7**—Rock plug near SRT Gate

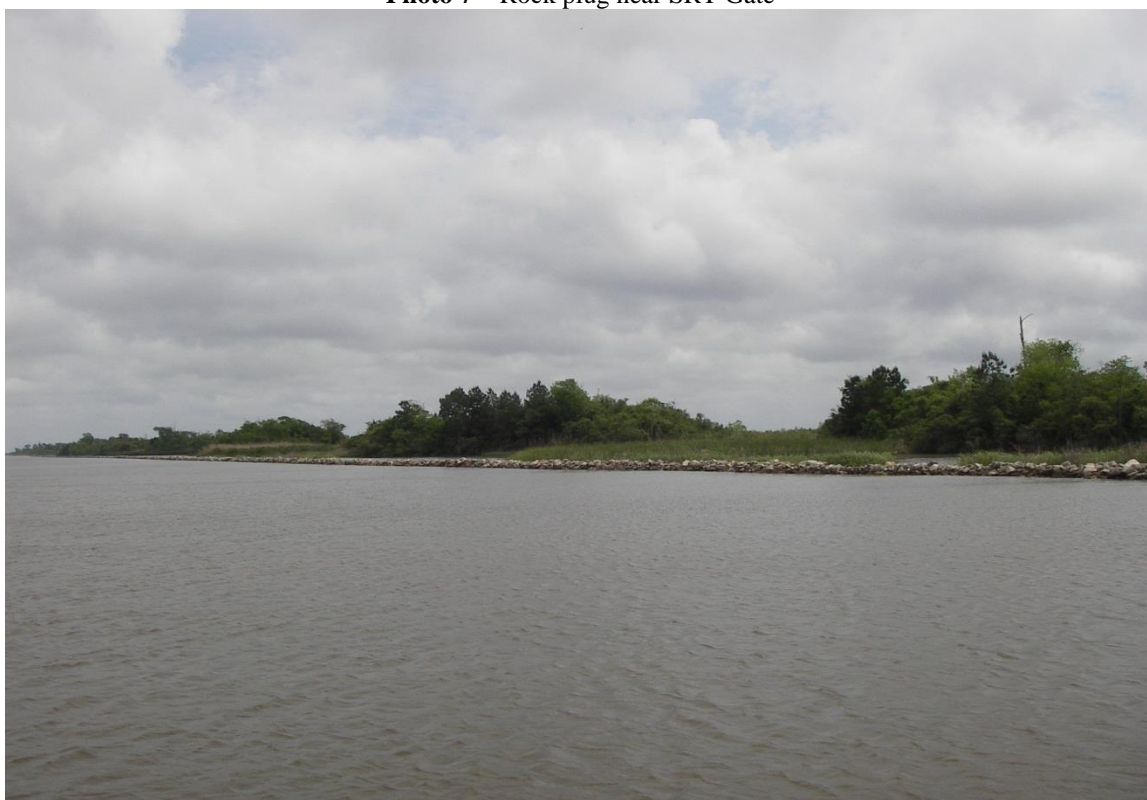
**Photo 8**—Typical section of rock dike

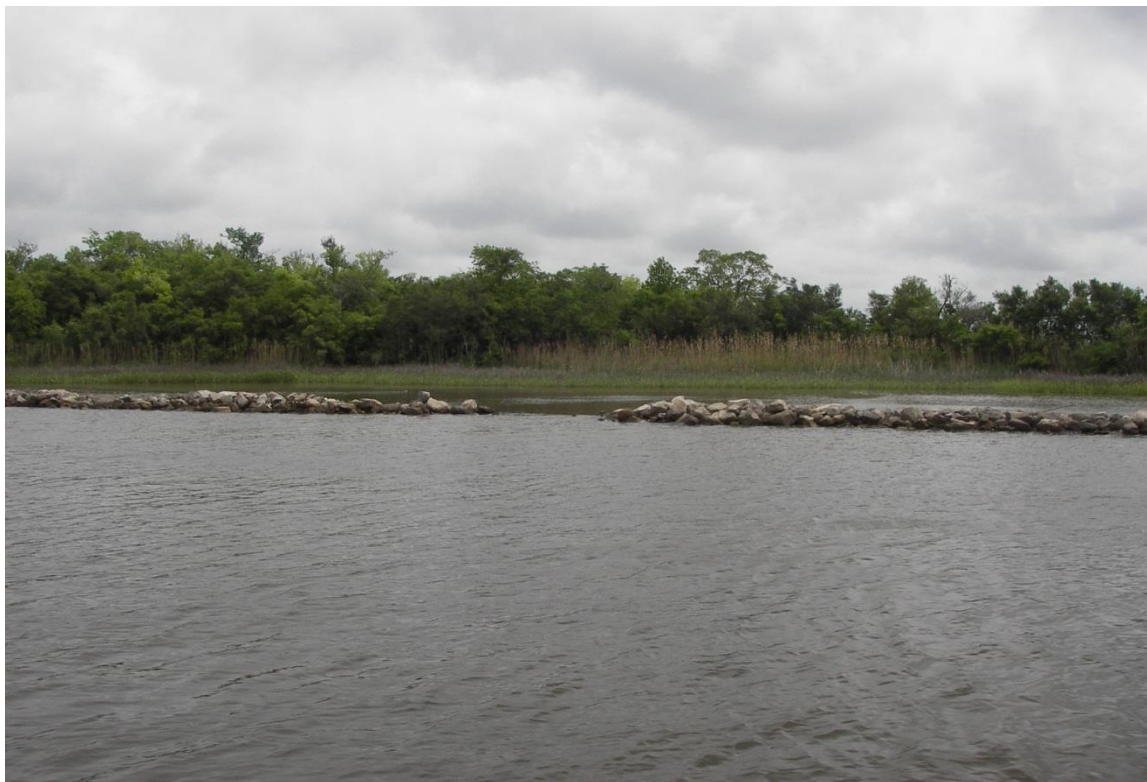
**Photo 9**—gap in dike with new vegetation between dike & shoreline

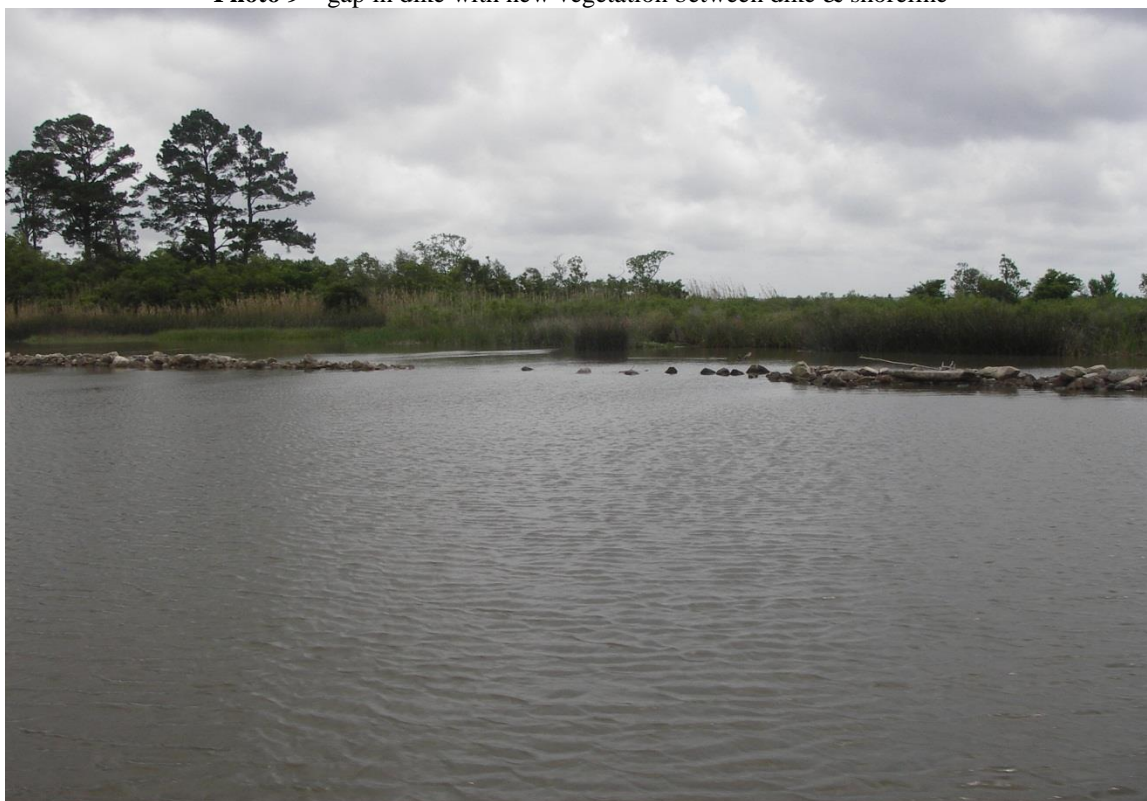
**Photo 10**—gap in dike

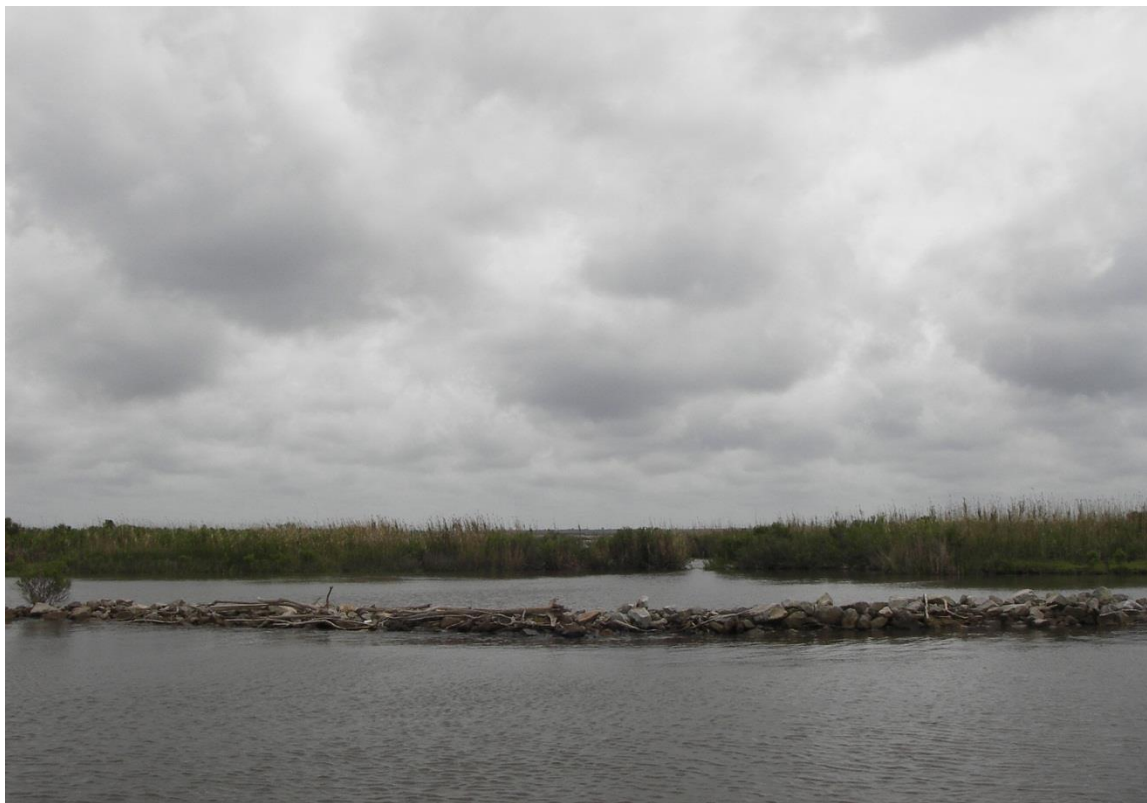
**Photo 11**—break near closure behind dike

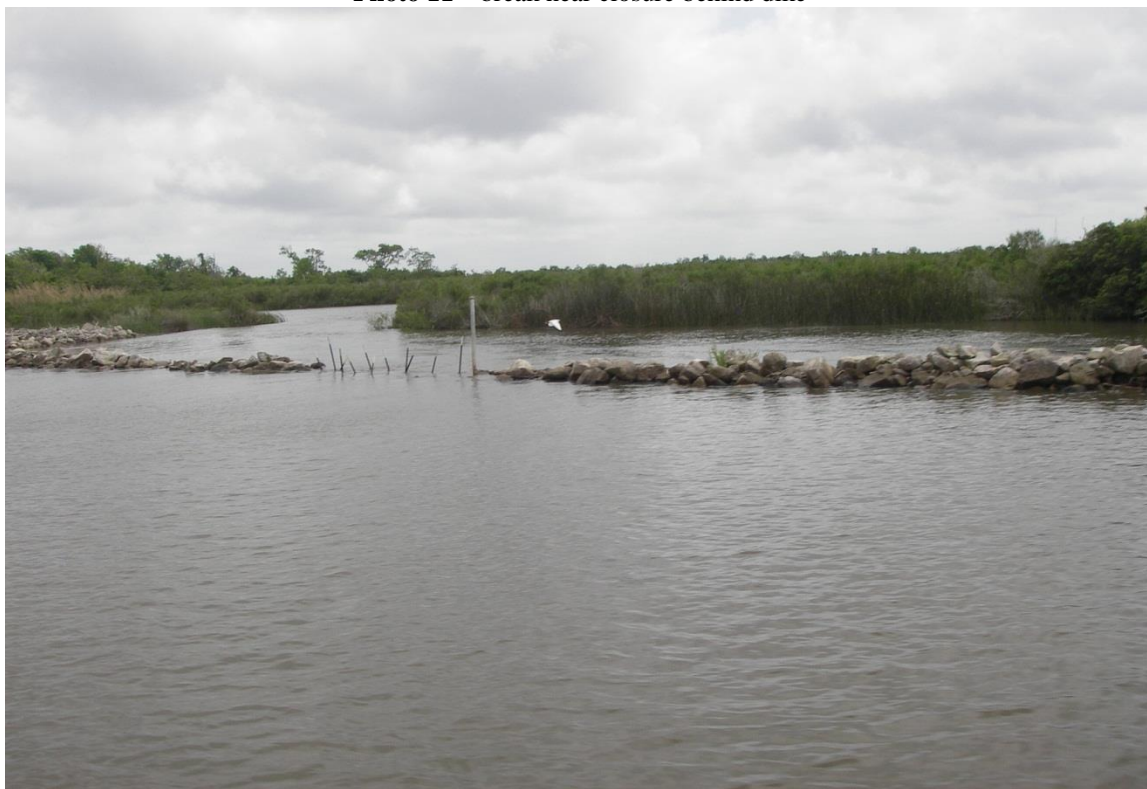
**Photo 12**—gap in dike and break near closure behind dike

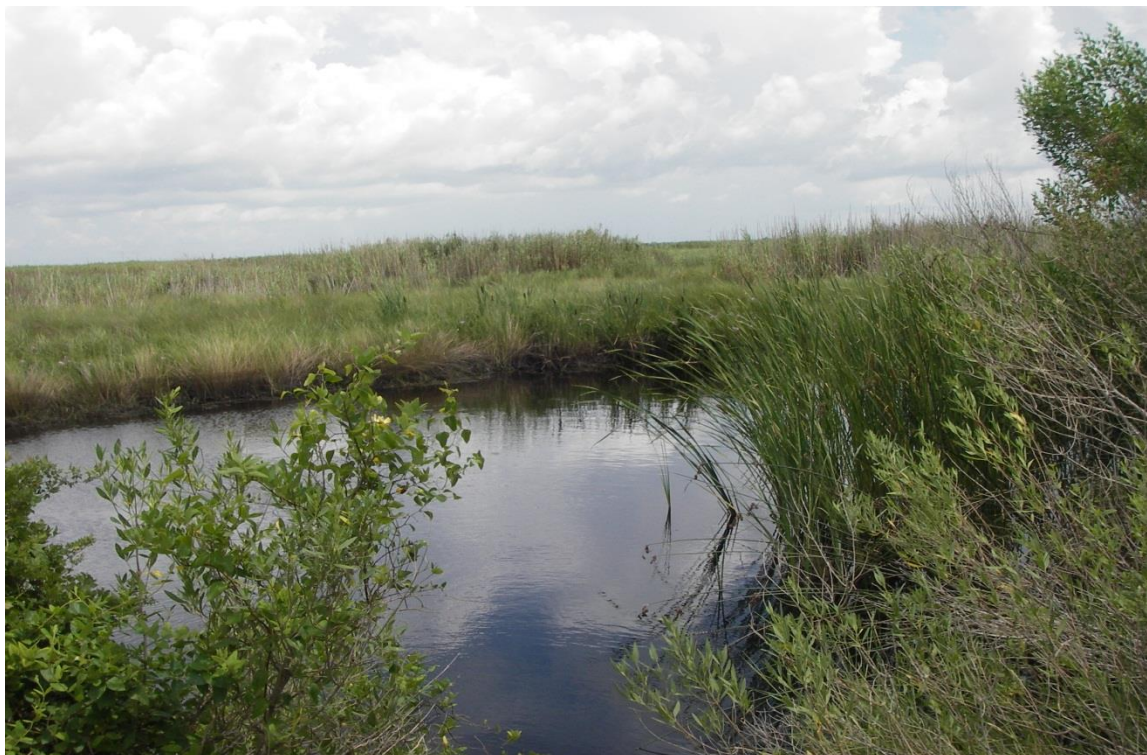
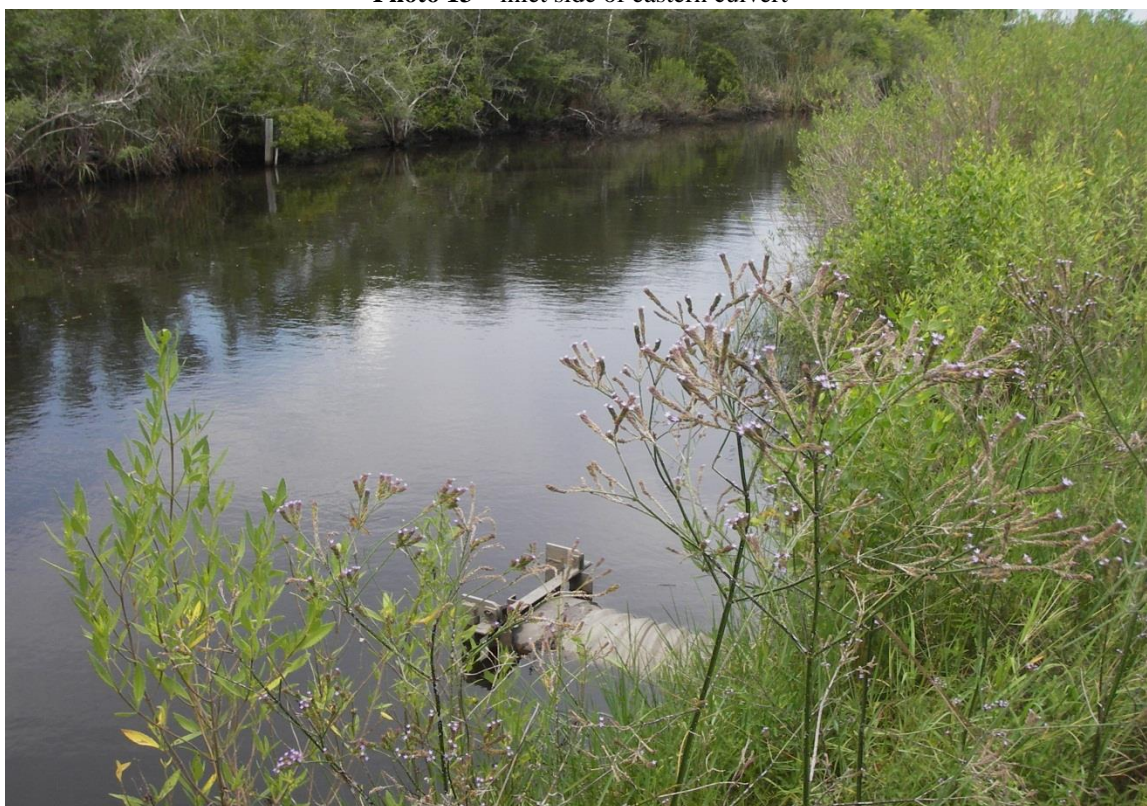
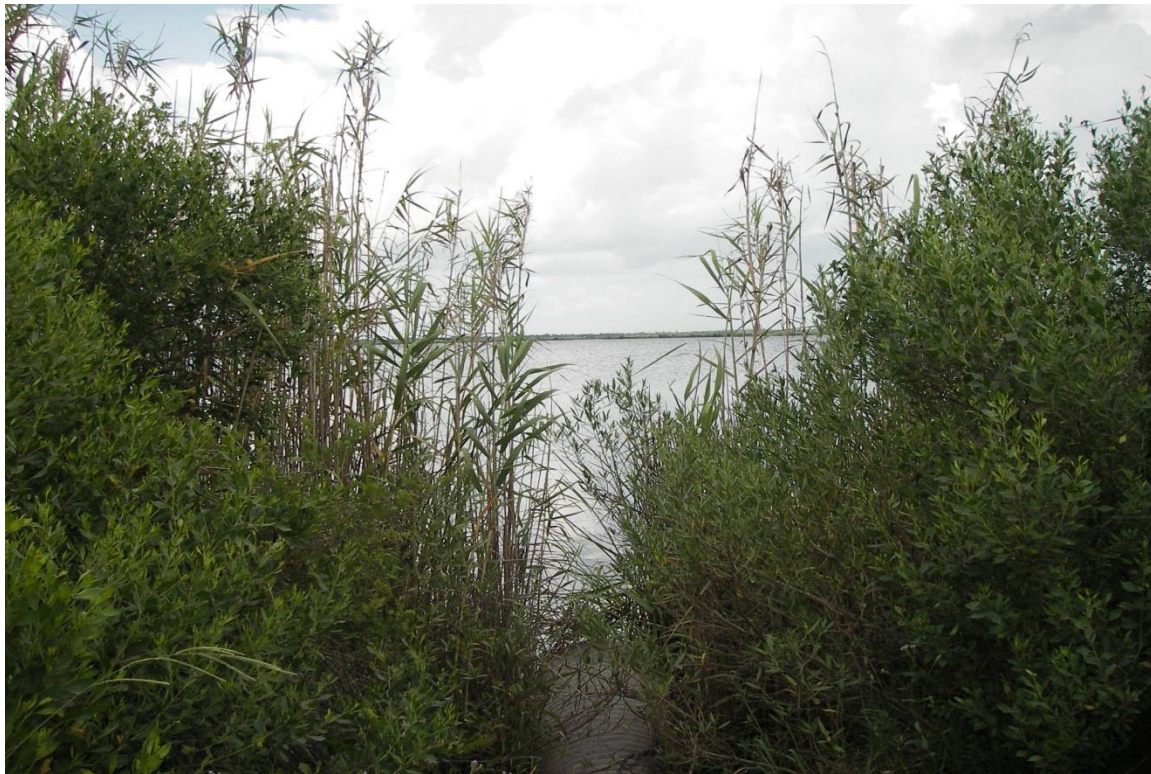
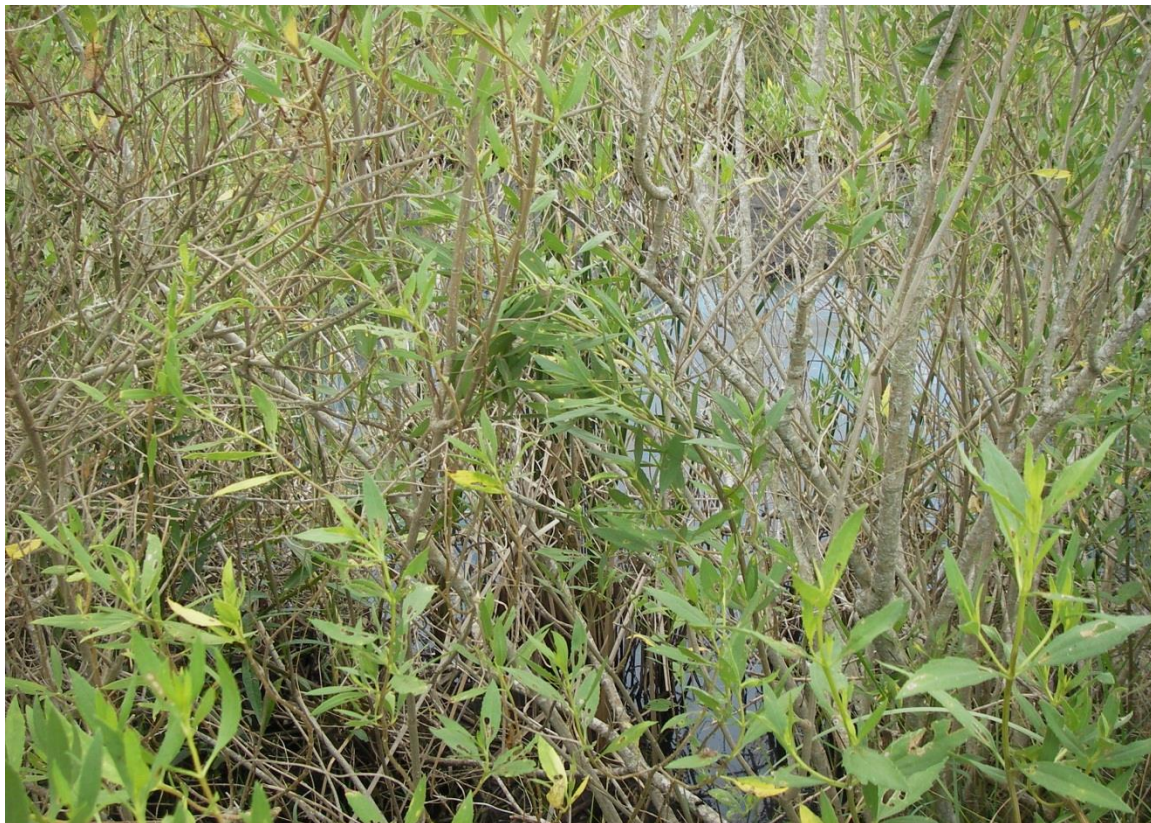
These culverts were inspected on June 26, 2015. They appear to be in very good, post construction condition and in no need of repair. No concerns have been expressed by the landowners. (Photos: Appendix A, Photos 13-16)
